Illinois Commerce Commission

Assessment of

Mt. Carmel Public Utility Company's

For Calendar Year 2006

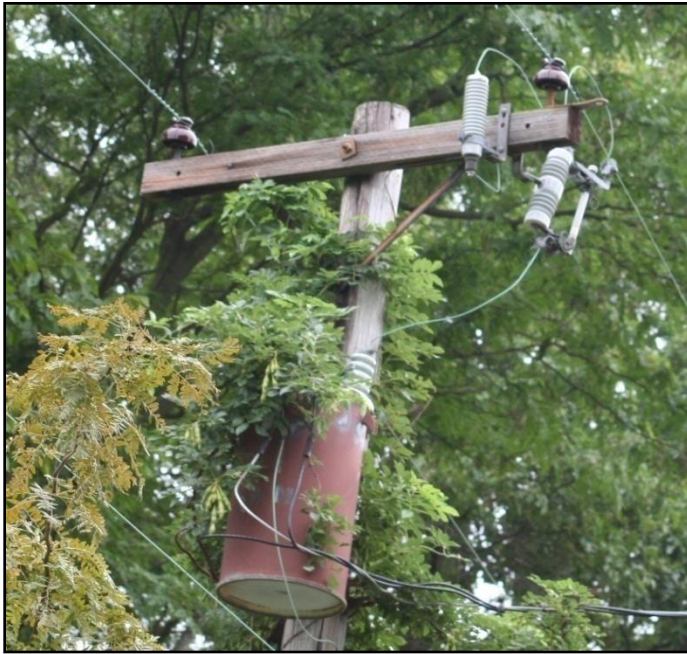
When inspecting Circuit 31000, Staff noted 20 locations where vegetation in the form of recent tree growth or fast-growing vines, was close to or contacting the primary conductor. Staff also noted two locations with loose hardware, and one location with a National Electrical Safety Code ("NESC") violation where MCPU used single, rather than double, cross arms at a railroad crossing. Circuit 31000 is quite lengthy, with several line sections traversing fields where the conductor is not visible. Overall, Staff found that the condition of MCPU's distribution facilities was quite good. Staff encourages MCPU to schedule mid-cycle tree trimming if MCPU is unable to trim in such a manner that the trees and/or vines do not contact the conductor between cycles. In addition, to aid in locating and isolating future circuit problems, Staff suggests that MCPU consider installing overhead fault indicators where the circuit leaves the roadway to traverse fields or back lots, and where the line again becomes visible.

Photo 1: Vegetation covering transformer (31000)

- MCPU's tree trimming personnel should clear trees away from the conductor in such a manner that the trees will not grow or blow into the lines prior to being trimmed again. Staff noted several tree contacts when inspecting MCPU's distribution circuits in July of 2007. MCPU's assertion that it trimmed all of the grids in its operating area within three years is a positive step, but MCPU must trim trees in such a manner that the trees do not contact the power lines between cycles.
